Service-News Tectalk Freestyle

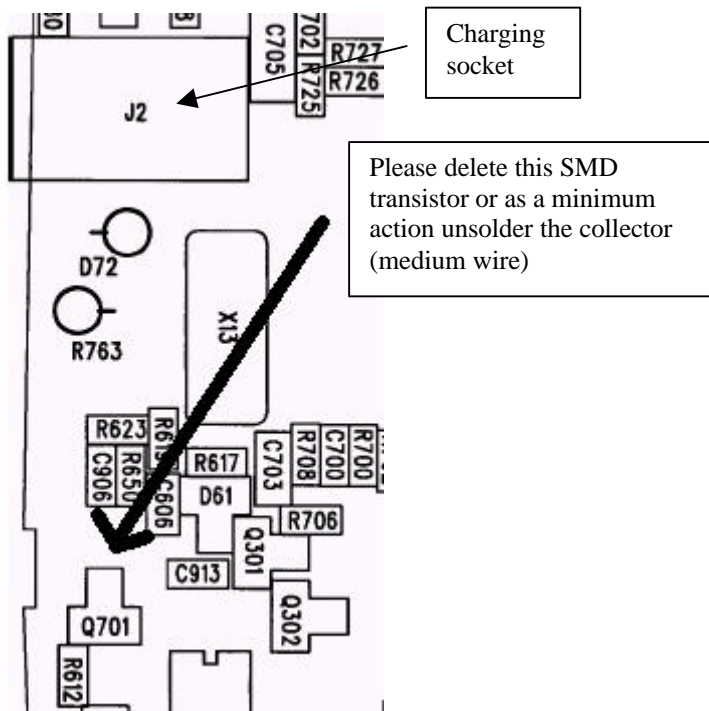
Radios of the first shipment February 2001 may have a missing function:

Roger Beep (described on page 10 of the german user manual, but not mentioned in the english manual) cannot be programmed.

In addition to this phenomena, the **VX** display Icon **remains blinking for some seconds** after programming and confirming the setting by PTT key.

Caused by a misunderstanding, the factory has inserted an additional transistor switch to inhibit Roger Beep function.

If Roger Beep beep is desired, it is possible to delete the transistor Q 701. The SMD part is easy to find near to the charging socket on the main board. The transistor can be deleted, as minimum action we recommend to unsolder the collector (medium contact).

All Tectalk Freestyle will be shipped with programmable Roger Beep Function from March 2001
